Preventing Erosion in the Skaneateles Lake Watershed

A Guide to Maintaining Shorelines, Camp Roads, Streambanks and Shorelines in the Skaneateles Lake Watershed.

Cornell Cooperative Extension
Onondaga County

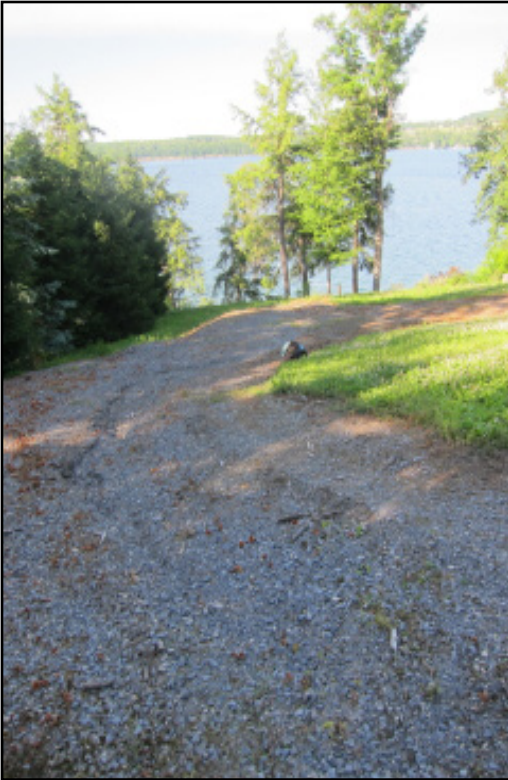
Improper crowning and siting of this camp road led to nearly immediate erosion and deposition into the lake after significant tree removal.

Camp roads, while necessary, provide a low-resistance path for water moving along the ground and directly into surface water. Water shed from camp roads can strip soil from the roads, reducing road safety and depositing contaminants directly into lakes and streams.

Erosion can be prevented on camp roads by using a variety of best management practices (BMPs) such as proper crowning, vegetated ditches, ditch turnouts and water diverters such as rubber bars and open-top culverts can prove very effective in reducing erosion and sedimentation.

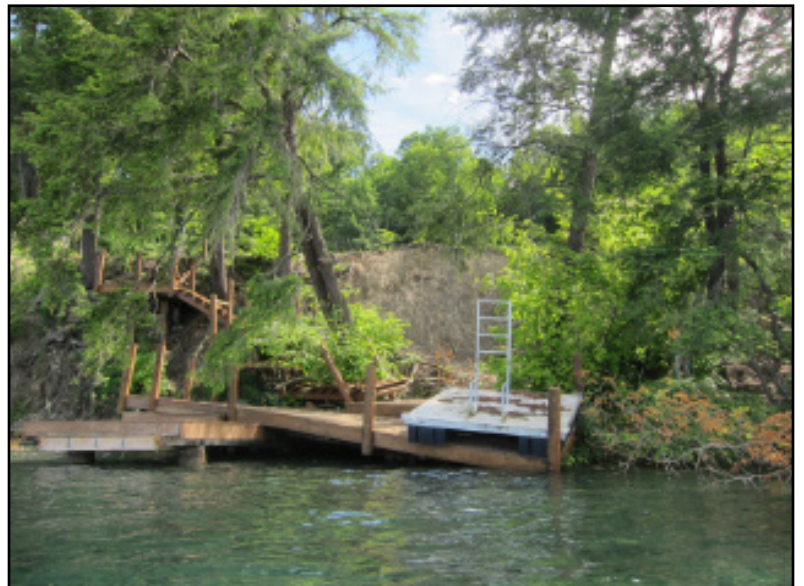
Lakeview of improperly sited camp road causing erosion along the lakeshore.

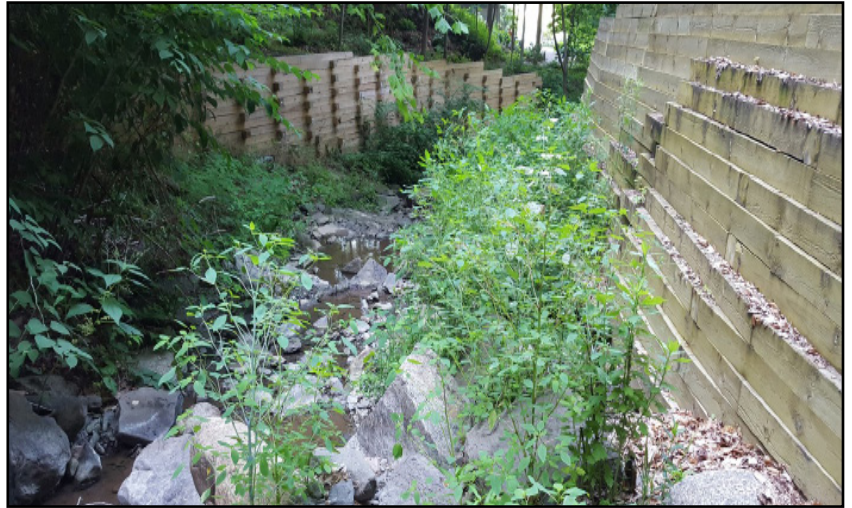
Cribbing alongside a stream in the Skaneateles Lake Watershed.

Hard structures such as cribbing (as seen above) and rock rip-rap can be used to armor stream sides from erosion. These methods, while effective, are often expensive and difficult to implement - especially in areas such as the Finger Lakes watersheds in which access to the site is troublesome. Artificial structures will move the energy of the water downstream, potentially causing more problems for neighboring landowners whose stream banks are not protected.

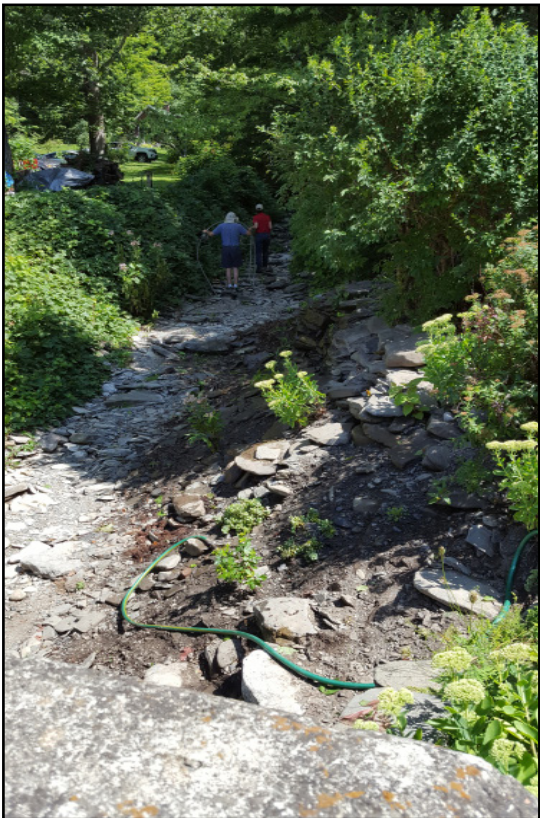
Volunteers plant native species to help stabilize a streambank near Glen Haven, NY.

Similar to protecting lake shorelines, an effective approach is often a combination of hard structuring with the implementation of native plantings to both reinforce man-made materials and to create or extend riparian habitat for amphibians, birds and small mammals. This integrated management approach can also result in a significant reduction in the cost of installation and maintenance in the future.

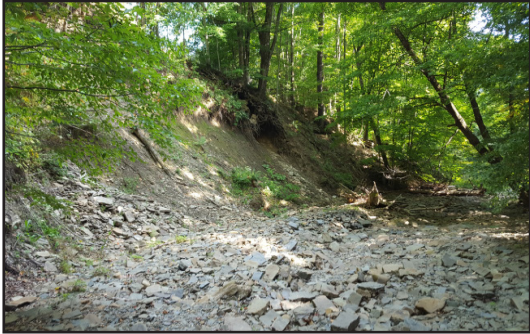
Exposed Soil Newly exposed soil along the banks of streams is a sure sign of erosion. Streams begin eroding the toe of a slope, gradually working up the slope, exposing more soil and subjecting more material to be easily washed down stream and deposited.

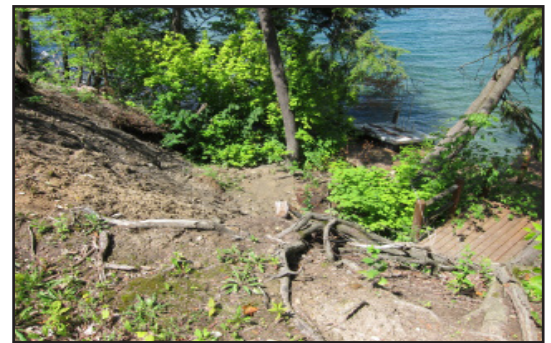
Root Undercutting and Tree Falls As shorelines and stream sides are undercut by increased stream flow or wave action, the trees which held the soil in place begin to fall as the substrate beneath them disappears. This eventually leads to less protection of the soil against rainfall and more exposed soil as a result.

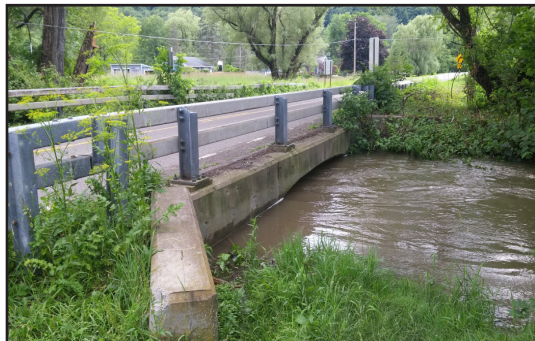
Turbid or Cloudy Water Stream flow colored like chocolate milk or more cloudy than normal is an indication of erosion upstream, often common after large storm events or during spring snow melt. The large quantities of sediments are deposited in lakes and cause issues for drinking water quality and can be hampering to native species habitats.
